A gauge set dropping to zero at 2:14 on a sweltering afternoon usually gets blamed on the condenser.

So what tells you an **hvac line set** is at the end of its useful life?

Usually, it starts with seven very specific clues.

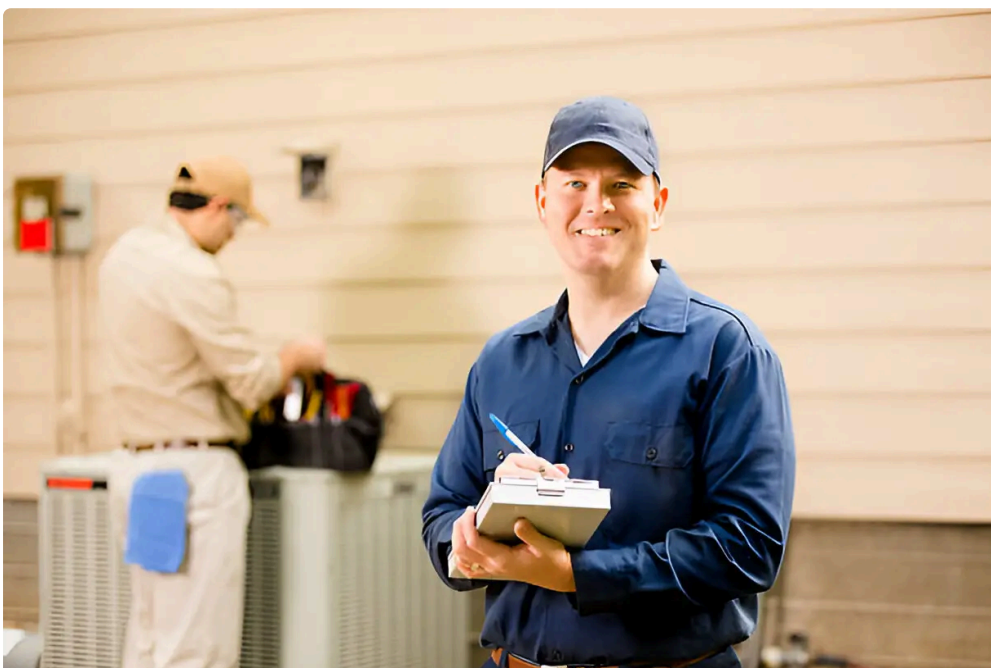
## #2. Insulation Pulling Away From the Tubing — Condensation Damage Usually Comes Next

When insulation separates from the copper, the tubing loses thermal protection and the exposed section begins to sweat. On a suction line, that can lead to water stains, mold, and efficiency loss long before anyone notices refrigerant trouble.

On a cooling system, the **suction line** can run cold enough to condense moisture aggressively in humid climates. Once the insulation gaps open, water starts forming at those weak points, especially near bends, line-hide exits, and attic transitions. In Gulf Coast and Southeast conditions, foam below an **R-4.2 insulation rating** can struggle to prevent sweating when relative humidity pushes past 90%.

Marisol told me the failed run on that Bakersfield office had jacket separation right where the installer forced a tight turn behind the condenser. Once the foam peeled back, UV exposure accelerated the failure.

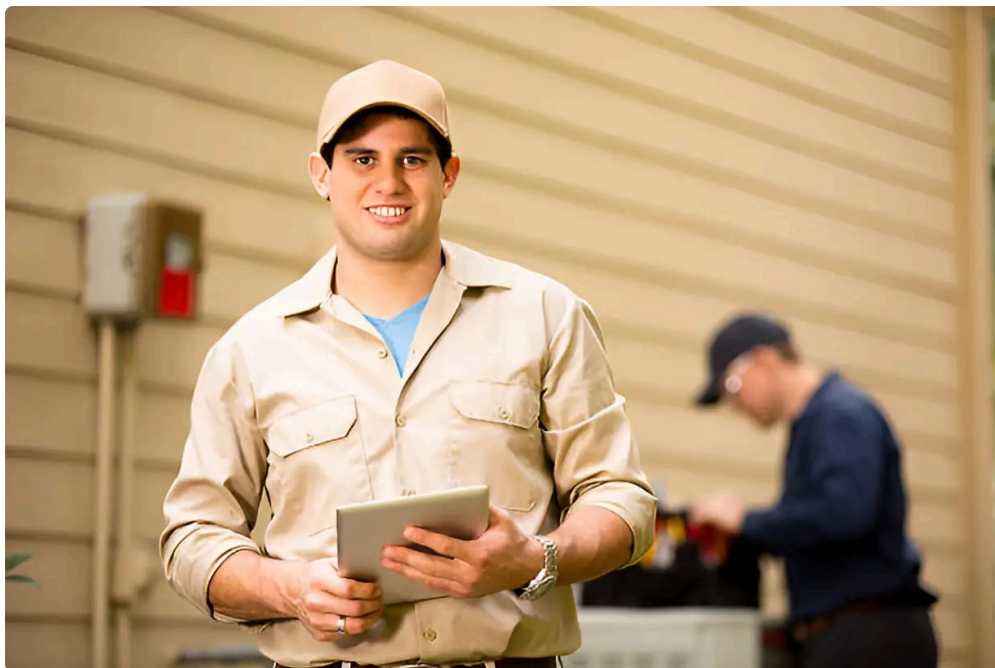
## **#3. Sun-Baked, Cracked Exterior Jacket — UV Exposure Has Already Shortened the Line's Life**

A cracked or chalky outer jacket means the insulation has been losing its weather resistance for months, sometimes years. Once UV gets through the surface layer, the foam underneath dries, splits, and stops protecting the tubing.

Bakersfield is brutal on exposed materials. Marisol's first failed **mini-split copper lines** run had outer jacket cracking before the second summer was over. Once the jacket failed, the insulation dried and shrank, and the copper underneath started seeing extreme daily heat swings.
